PLANNING AHEAD PROVES INVALUABLE  
TO THE RAPID RESTORATION OF THE PACIFIC DC  
INTERTIE AND OWENS GORGE TRANSMISSION LINES

STEPHEN A. RUTTY   JOHN K. JACKSON   DAVID A. DELUCA  
LOS ANGELES DEPARTMENT OF WATER AND POWER

PRESENTED AT  
11th IEEE/PES TRANSMISSION AND DISTRIBUTION  
CONFERENCE AND EXPOSITION  
NEW ORLEANS, LOUISIANA  
APRIL 2-7, 1989

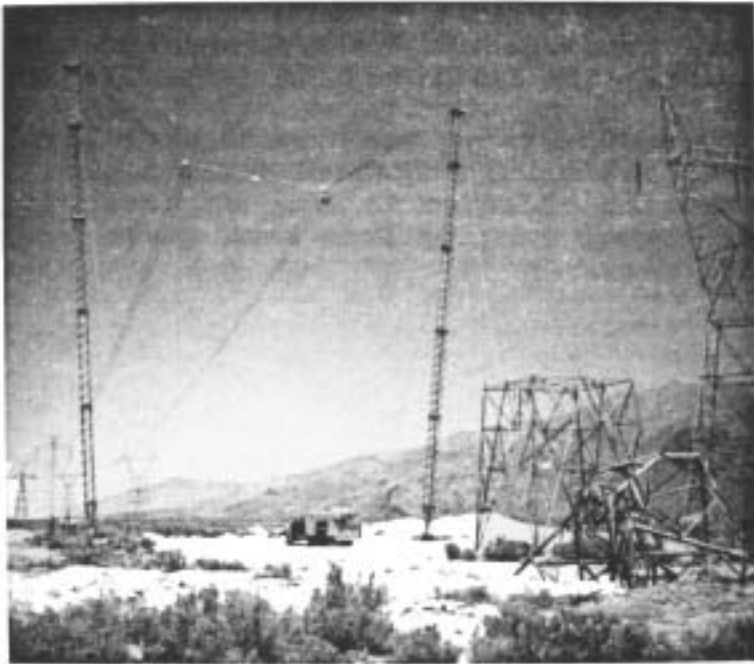
**Figure 2**

The light angle tower (right, foreground) was replaced with an emergency structure. The guyed permanent tower, which sustained minimal damage, was re-erected (left, background). A few months after the incident, the emergency structure was replaced with a new permanent tower.

Two of the four guy wires supporting a tangent tower had been cut, bringing that tower down and destroying a self-supporting light angle structure immediately to the south. Minor damage occurred to several towers immediately to the north and south of the downed structures.

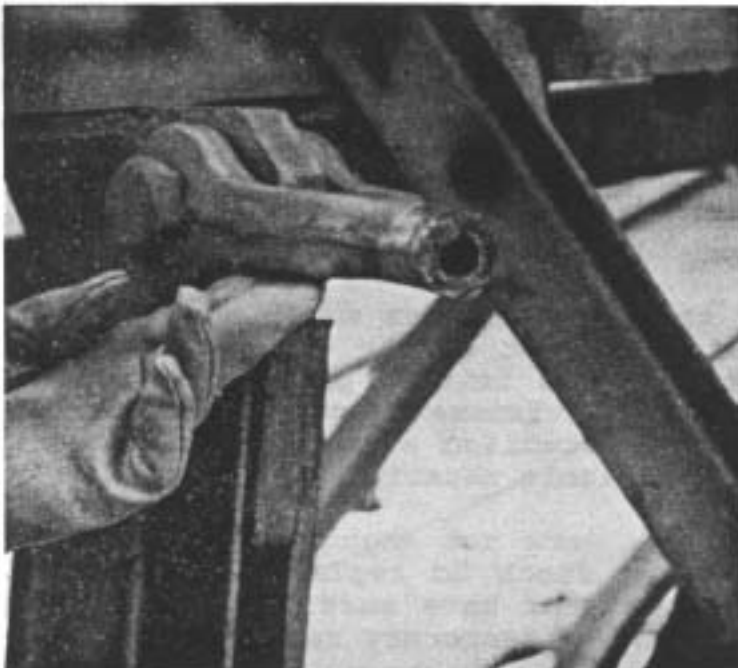
**Figure 5**

The probable cause of the emergency was the failure of both windward guy fittings of Tower 164-1. The failure was due to extreme temperature and wind loading conditions which exceeded the original design criteria (see Figure 5). Although the cause of this emergency is important, the primary focus of this paper is on the actions which were taken to restore the lines to service. All utilities face the possibility of emergency situations and the lessons learned from this incident may prove helpful.

This figure shows a typical guy hardware failure. 15 of the 16 guyed towers which went down exhibited a similar failure of one or two guy fittings. LADWP is currently undertaking a program of changing out these fittings.

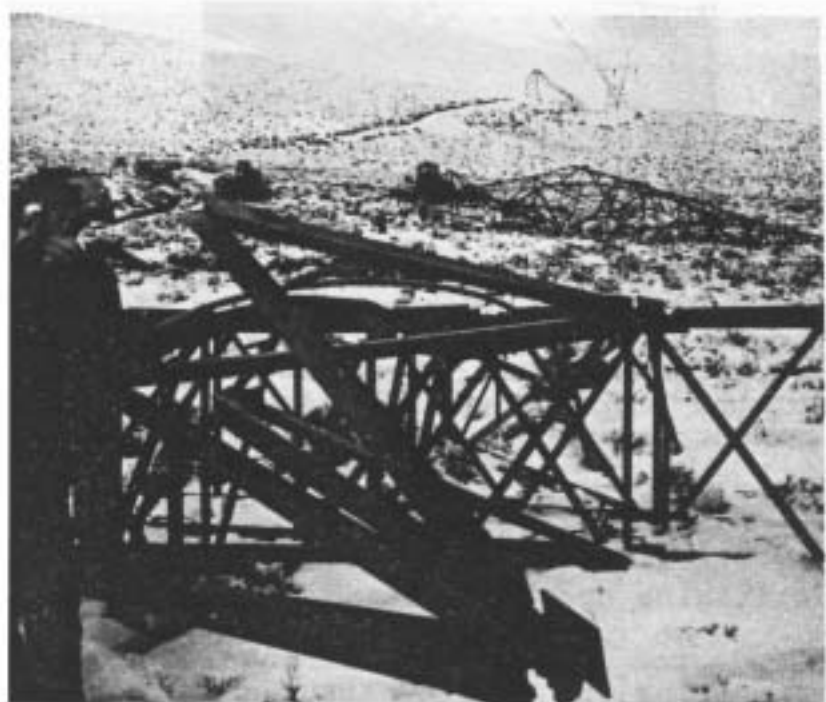
**Figure 8**

Many of the DC towers collapsed across existing access roads making it essential to clear new roads. Since much of the collapsed steel was salvageable, care had to be taken during removal to prevent further damage. In the background is the only self-supporting tower that collapsed.

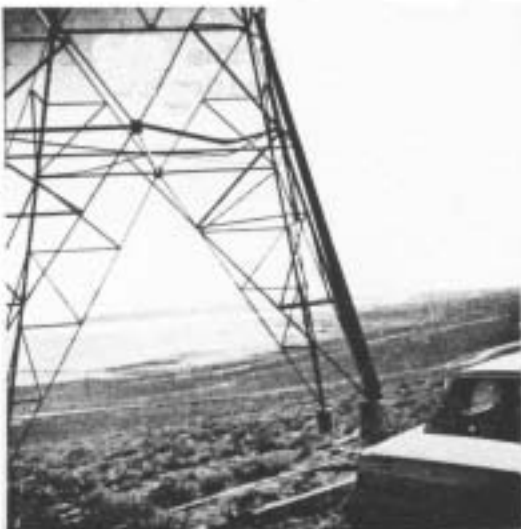
Figure 9

Damaged critical steel members of towers were replaced with new steel members made in LADWP steel fabrication shops in Los Angeles. Towers with damaged legs were braced with wood poles to prevent the legs from buckling (see Figure 9).

Each damaged tower was fully inspected for bent steel or other structural problems. In several cases wood braces were used instead of replacement steel in order to save time and speed the line back into service.

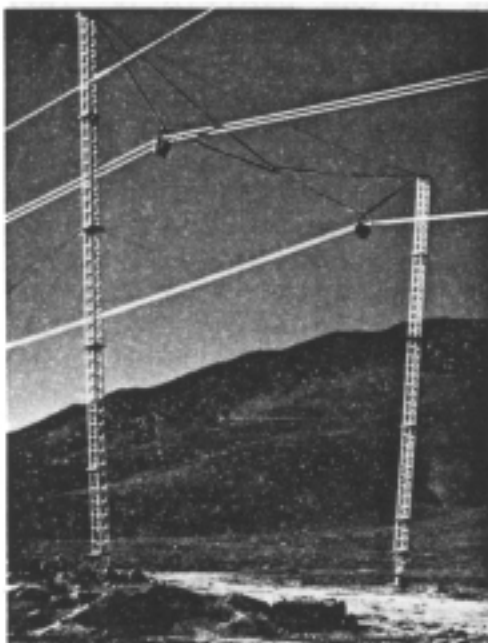
**Figure 10**

The emergency structure configuration used by LADWP consisted of two 106 foot columns with a chainette insulator arrangement supporting the conductor (see Figure 10).

The emergency structure was guyed at the top and at the 64 foot level using a total of 36, 7/16 inch guy wires and 6 direct buried, concrete plug anchors. An additional guy was used to connect the two columns at the 64 foot level. To compensate for the ground slope and to keep the top of the structure approximately level, the height of the uphill columns were varied using the modular sections.

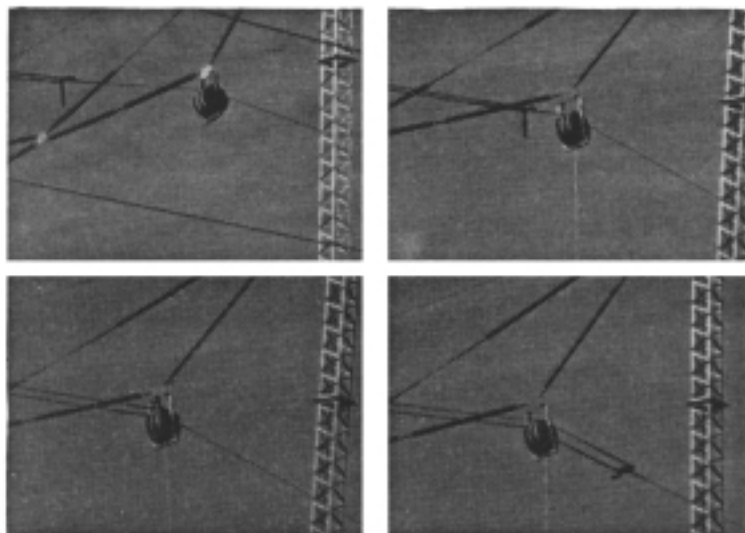
Figure 11

LADWP's stringing operation represented the first time the chainette insulator assembly of the emergency structures had experienced stringing. This sequence of photographs shows the running board coming from the longest span of 1374 feet. The running board caused minimal swing in the chainette assembly.

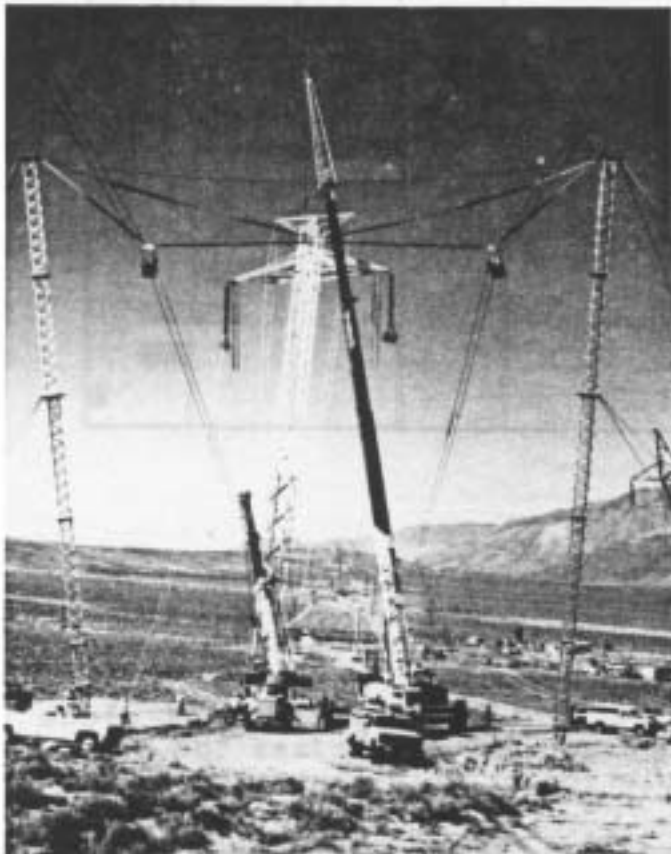
**Figure 14**

A 90 ton Grove crane was used to raise the permanent towers between the two poles of the DC line. A smaller crane was used at the base of the permanent tower to position it on the foundation. Once upright, the four guys of the permanent tower were used to plumb and secure the structure.

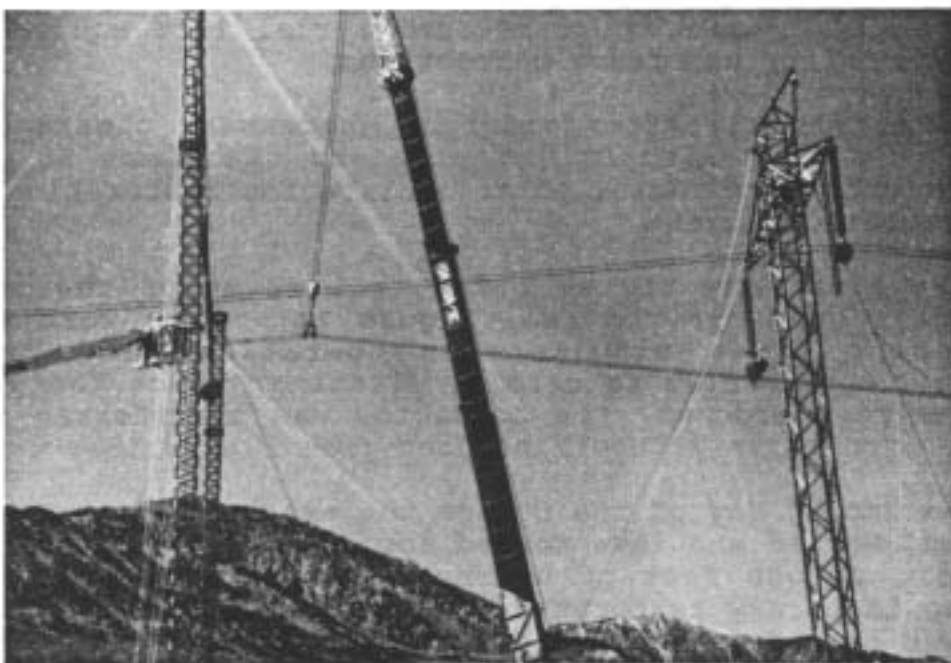
**Figure 15**

The same 90 ton crane used to erect the tower was used to transfer the conductors from the temporary structure to the permanent tower (below). Once the conductors had been transferred, the 90 ton crane moved to the next structure while additional crews began disassembling and removing the temporary towers.

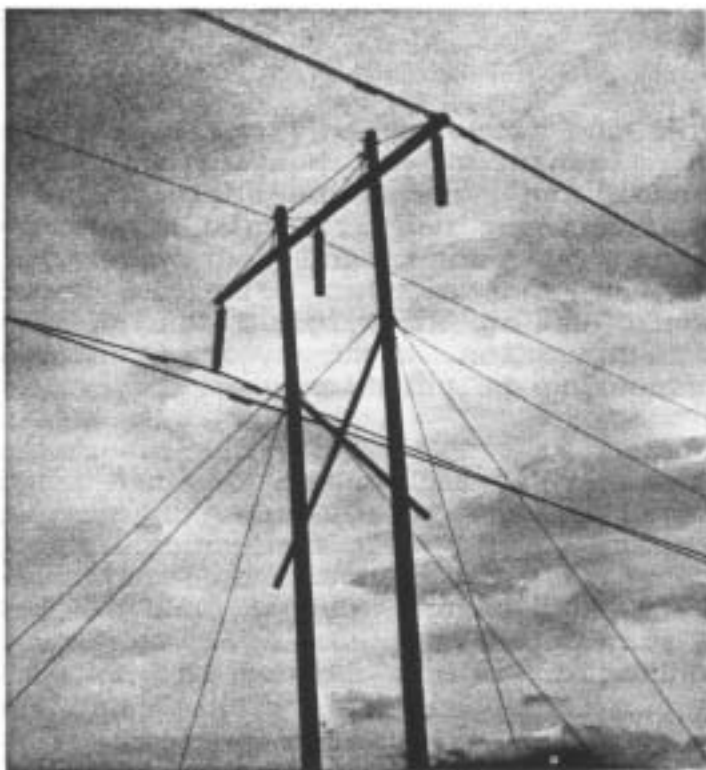
**Figure 17**

Conductor and groundwire was constrained at the temporary "H" frame structures, to allow the new suspension type tower to be erected. Being able to erect this new tower without removing the conductors reduced the required outage time.

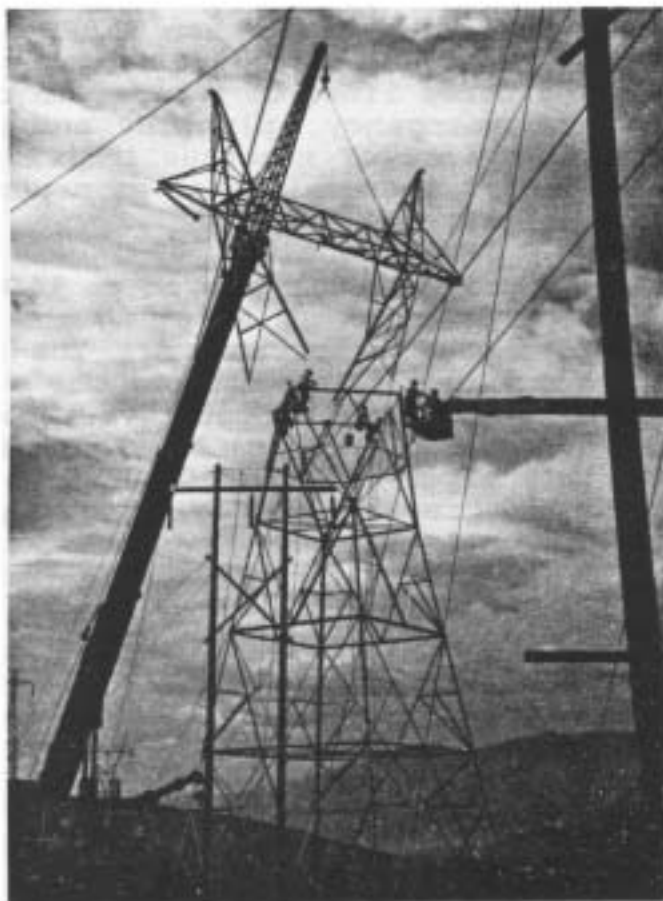
**Figure 18**

This overview shows the new replacement tower being erected between and the temporary structures. Also shown is the proximity of the equipment to the structures.
