TRANSMISSION LINE RESTORATION TECHNIQUES IN COLOMBIA, SOUTH AMERICA

Mario Aristizabal

Interconexión Eléctrica SA

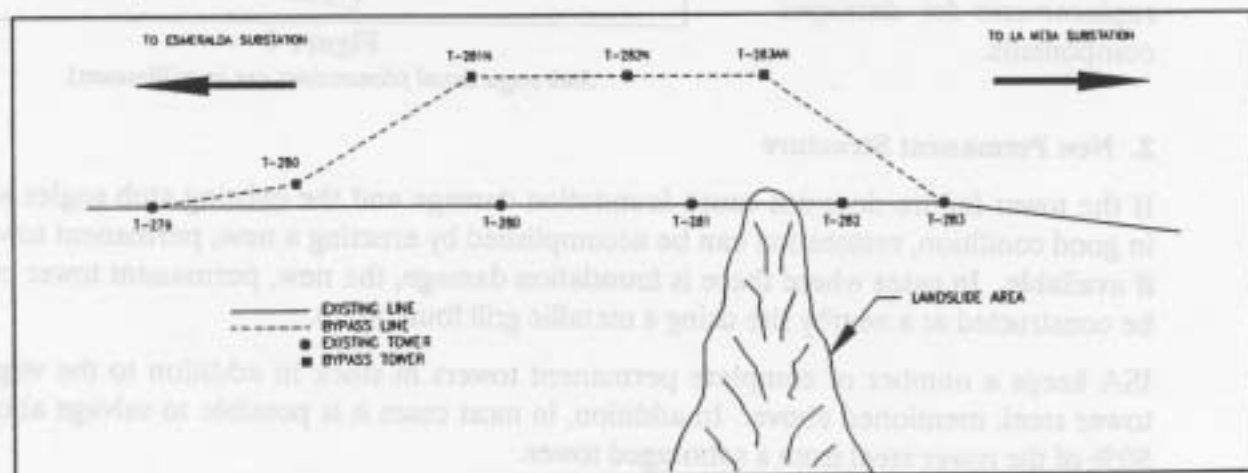
Figure 3

In a number of areas, problems with soil erosion and landslides have made it necessary to reroute the transmission line around problem areas (Figure 3). In less severe cases, wood, concrete and metallic retaining walls have been constructed to stabilize the area around tower footings. ISA has also planted new vegetation and built special drainage ducts on some slopes in an attempt to stabilize the soil.

Due to a landslide affecting the stability of Tower 281, a bypass restoration was built.

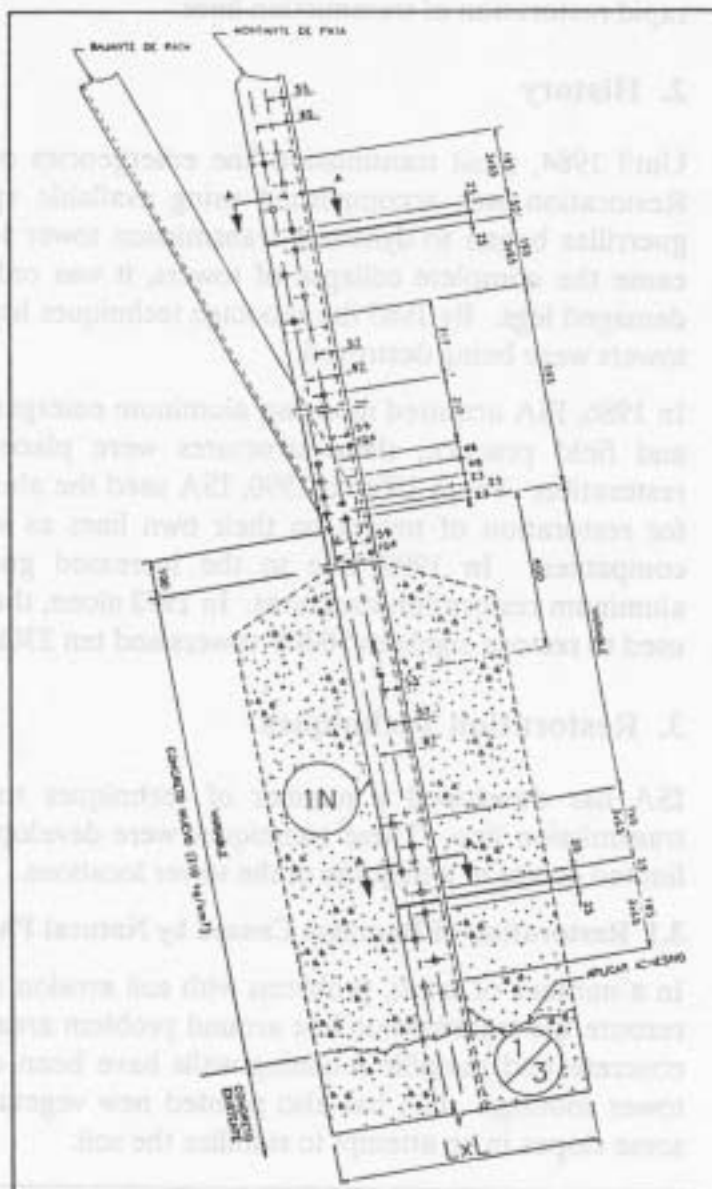
Figure 4

Stub angle detail (dimensions are in millimeters).

In cases where the damage to a structure is not sufficient to cause complete collapse, restoration can be accomplished by repairing the damaged tower steel. ISA constructs the tower stub angles with a spliced connection in the upper portion of the footings (Figure 4). With this type of construction, repair can be accomplished by chipping away only the upper portion of the footing and replacing the damaged stub angle. ISA also maintains a supply of virgin tower steel, particularly material that is not readily available in Colombia, to rapidly fabricate replacements for damaged components.

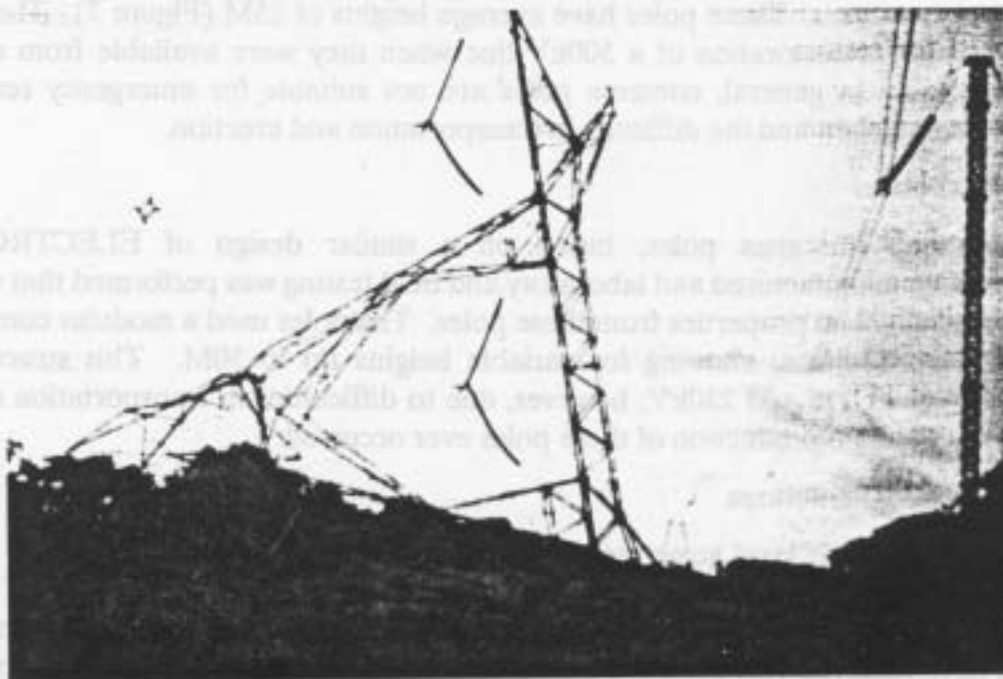
Figure 5

Utilization of the collapsed tower for temporary restoration.

One of the first alternatives considered, especially at remote and inaccessible tower sites, is to leave as many phases as possible in service on the downed tower. For example, on double circuit towers that fall transversely, the upper circuit can often be left in service. On a single circuit tower, one and sometimes two phases can be left on the failed tower and reenergized, with only the one phase actually in contact with the ground being moved to a temporary structure (Figure 5). In some cases, fiberglass rods or insulators are used to limit the conductor motion and insure that all required clearances are maintained. If needed, the collapsed tower is stabilized with guy wires.

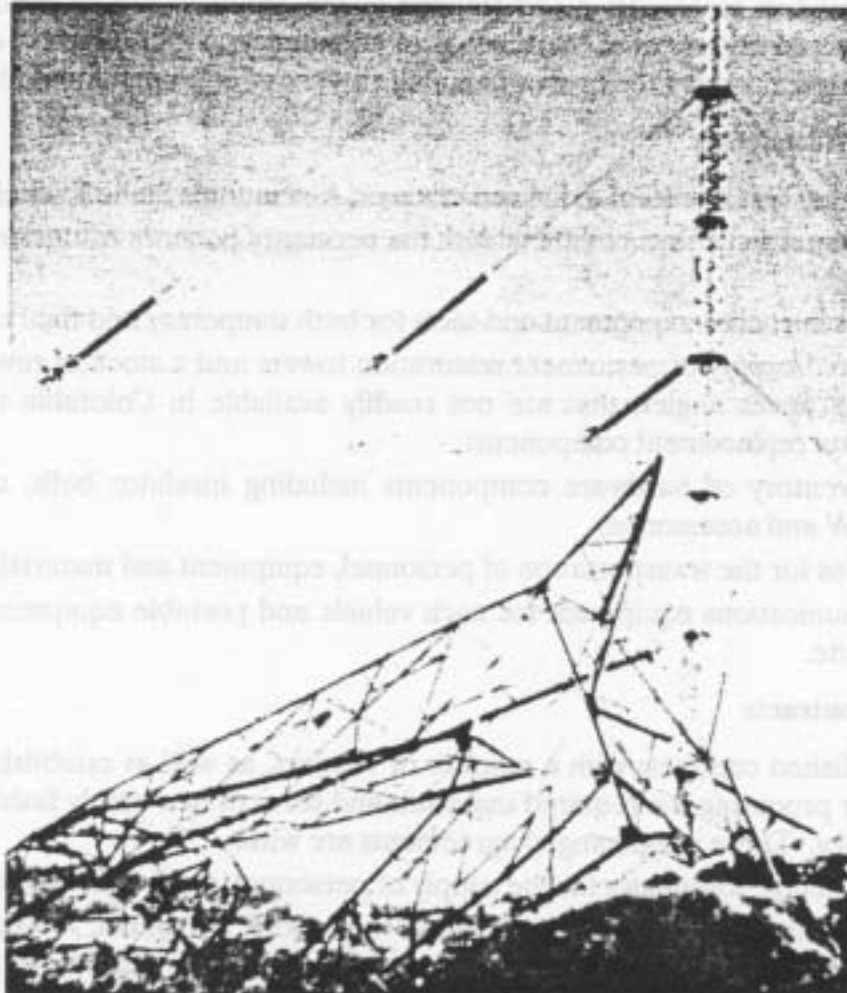
Figure 10

ISA has designed a number of unique configurations using the modular, aluminum restoration structures, including this 500kV three phase running angle structure used to restore a sabotaged 90° tension structure. To get an idea of the scale, note the lineman working on the outer conductor bundle.
