# **Recent Experience Restoring Damaged Transmission Lines by National Power Corporation of the Philippines**

R. "Rex" F. Corpuz  
National Power Corp.  
Philippines

Reprint from Power Delivery Asia, 1 October 1998, New Delhi, India

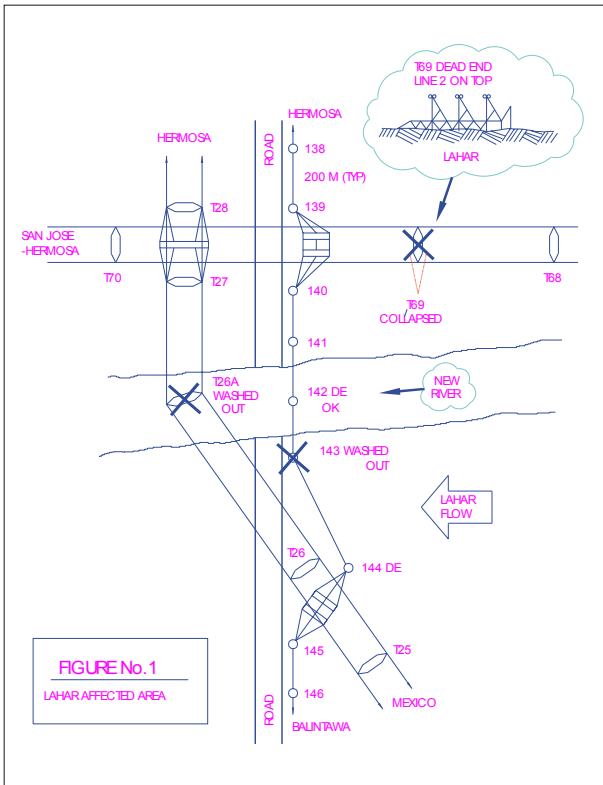
In October 1995 after a heavy tropical storm, a large flow of lahar (a mixture of ash and water from Mount Pinatubo) destroyed five circuits of 230kV transmission lines that supplied the city of Manila (Reference 2). At that time these five circuits carried an average 1200Mw of power to Manila. Figure 1 shows a plan view of the five circuits affected by the lahar flow.

The drawing to the left shows the lahar flow from right to left. Tower T26A on the Hermosa-Mexico and tower 143 on the Hermosa –Balintawak lines were washed away. Tower T69 on the San Jose-Hermosa line collapsed. All other towers were buried in 6-8m of lahar mud.

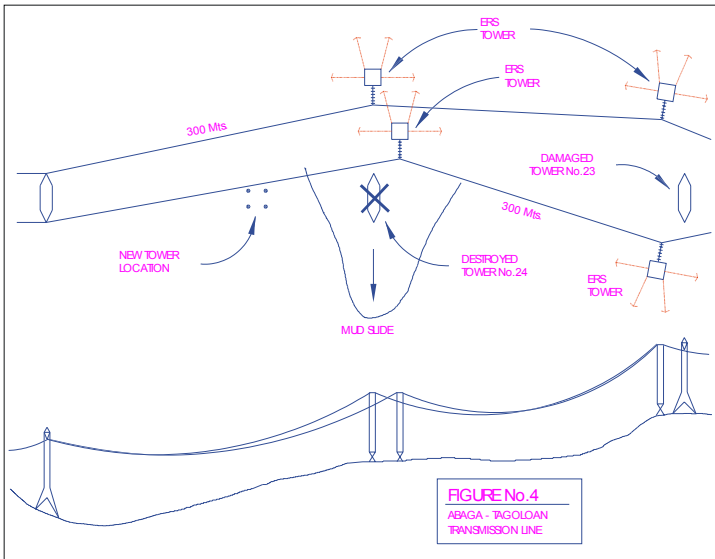
Figure 4

In October of 1996, heavy rains caused a massive mud slide that completely destroyed a full tension tower No. 24 and damaged a cross arm on suspension tower No. 23 on the Abaga-Tagoloan double circuit 138kV transmission line. A plan and elevation of the failure site is shown in figure 4.

The drawing above shows the placement of the four ERS horizontal-vee structures. The mud slide destroyed tower No. 24 and damaged a suspension arm on tower No.23.

Mr. Roberto Marzo, transmission line manager, and Mr. Simeon Clerigo, Lanao area manager, were responsible for the restoration of this critical transmission line. It was decided to restore both circuits with four horizontal-vee ERS structures. Due to the remote location, all ERS material had to be hand carried the last 2km to the site of the land slide. The four horizontal-vee ERS structures were built in five days using an aluminum gin pole and a small portable capstan hoist. The foundation of the ERS was placed on the sloping and unstable soil of the mud slide. It took an additional two days to transfer the conductor, figure 5 shows one of the circuits transferred and the ERS for the second circuit under construction. Both circuits were re-energized in seven days.

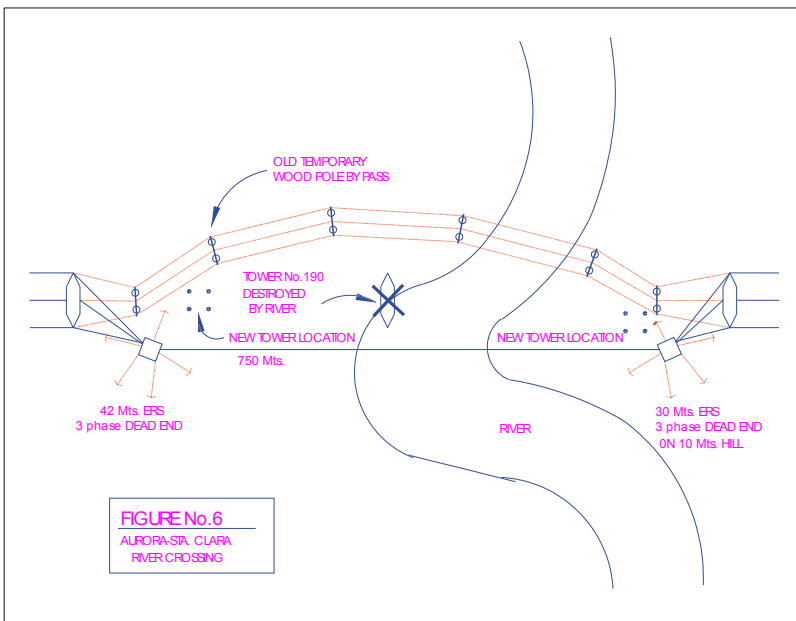
Figure 6

bypass was built utilizing six wood pole H-frame type structures. One year later the wood pole structures were failing for the same reason, the flooding and meandering river was washing out their foundations.

A 750m river crossing was constructed using two ERS tension structures. One was built 42m tall and the other, which was on a hill, only needed to be 30m tall.

Mr. Ruben Conti, transmission line manager, and Mr. Lorrymir S. Adasa, North Western Mindanao area manager, were given the responsibility of building a new bypass that would allow construction of new permanent river crossing towers. It was decided to install two full tension ERS structures to span the approximately 750m river crossing. Due to the span a 43m tall ERS tension tower was required in order to maintain clearance. A plan view of the ERS bypass is shown in figure 6.

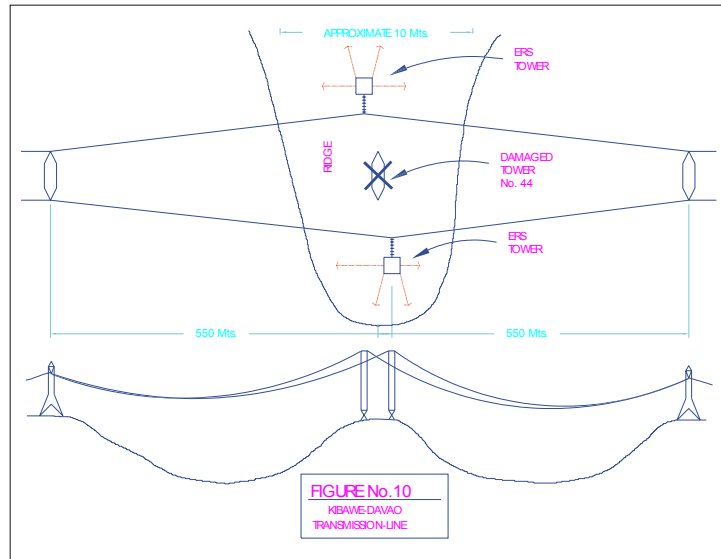
Figure 10

Vandals cut two legs on a double circuit 138kV tension tower, No. 44, on the radial feed Kibawe-Davao transmission line. The tower listed at a 45° angle but did not topple. NPC braced the tower with several guy wires in order to maintain the energized line. This line is a radial feed into a major city and could not be de-energized. When one circuit was de-energized, a 50 megawatt diesel had to be started up in order to maintain voltage at the load center. To complicate matters, the tower was located on the top of a narrow ridge, and the only access to the site was by helicopter. The plan and elevation of tower No. 44 is shown in Figure 10.

Vandals cut the legs of tension tower No. 44. This tower is located on the top of a narrow ridge. In order to keep the line energized, the conductor from one circuit was transferred to the ERS horizontal-vee structures while the other circuit was energized.

Mr. Ernesto Guinares, transmission line manager, and Mr. Emy Abellanosa, North Central Mindanao area manager, were given the responsibility of repairing this tower while always keeping one circuit energized. Their solution was to use two ERS horizontal vee temporary towers to bypass both circuits around the damaged tower. With these in place, the damaged tower could be replaced, as the foundation was not damaged. Access to this site was difficult. All line crews and equipment had to be flown in by helicopter. It took one day and 18 trips (of 20km each) to get all personnel and equipment to the site. Helicopters were required to fly in supplies everyday and the line crew camped at the site. Approximately 25 linemen were involved. A gin pole and small portable capstan hoist were used to construct each ERS horizontal vee tower. The horizontal vee towers were offset longitudinally from the damaged tower approximately 5 to 10ft on either side. Since the site was on top of a ridge, the back and side guys on the ERS horizontal-vees were two to three times longer than normal, as can be seen in figure 11. In order to minimize outage time of transferring conductor from the lattice tower to the ERS

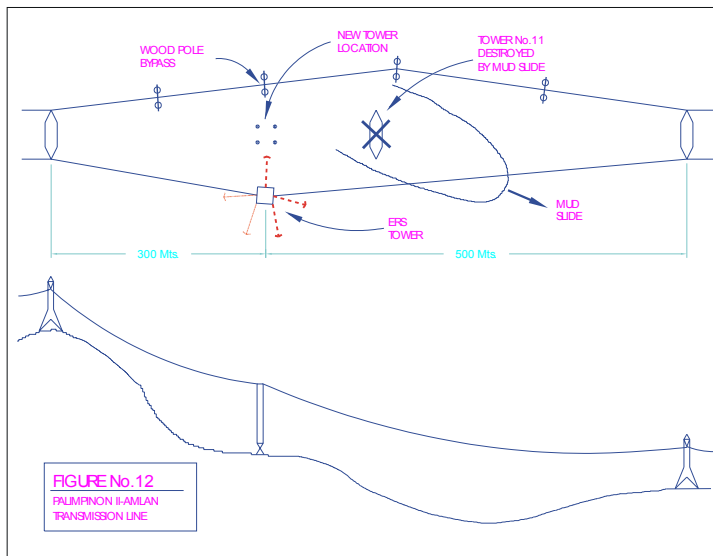
Figure 12

Mud slides destroyed tower No. 11 on the Palimpinon II-Amlan transmission line in the Visayas area. An ERS tension structure was erected to restore the second circuit.

Rain and heavy mudslides destroyed a 138kV double circuit suspension tower, Tower No. 11 on the Palimpinon II-Amlan transmission line, on the island of Negros, in the Visayas area of the Philippines. A temporary wood pole bypass had been constructed; however, this single circuit bypass was heavily loaded and was being threatened again by the mudslide.

Mr. Alfredo Arzaga, transmission line manager, and Mr. Manuel Terez, Central Visayas area manager, were given the responsibility of increasing the reliability of this line. As shown in plan and elevation view of tower No.11, figure 12, it was decided to erect an ERS full tension tower longitudinal, and outside of the mudslide area to carry one circuit of the 138kV line. The site was difficult to erect the ERS since it was located on a sloping hill. A gin pole was used to construct the ERS tension structure, as shown in figure 13. The line crews from the Visayas area used this for a training exercise and erected the ERS structure in only 2 days.
