400kV Restoration Withstands Flooding Advanced Planning Anticipated Effects of River Flooding

Restoration Summary

400kV Restoration Withstands Flooding

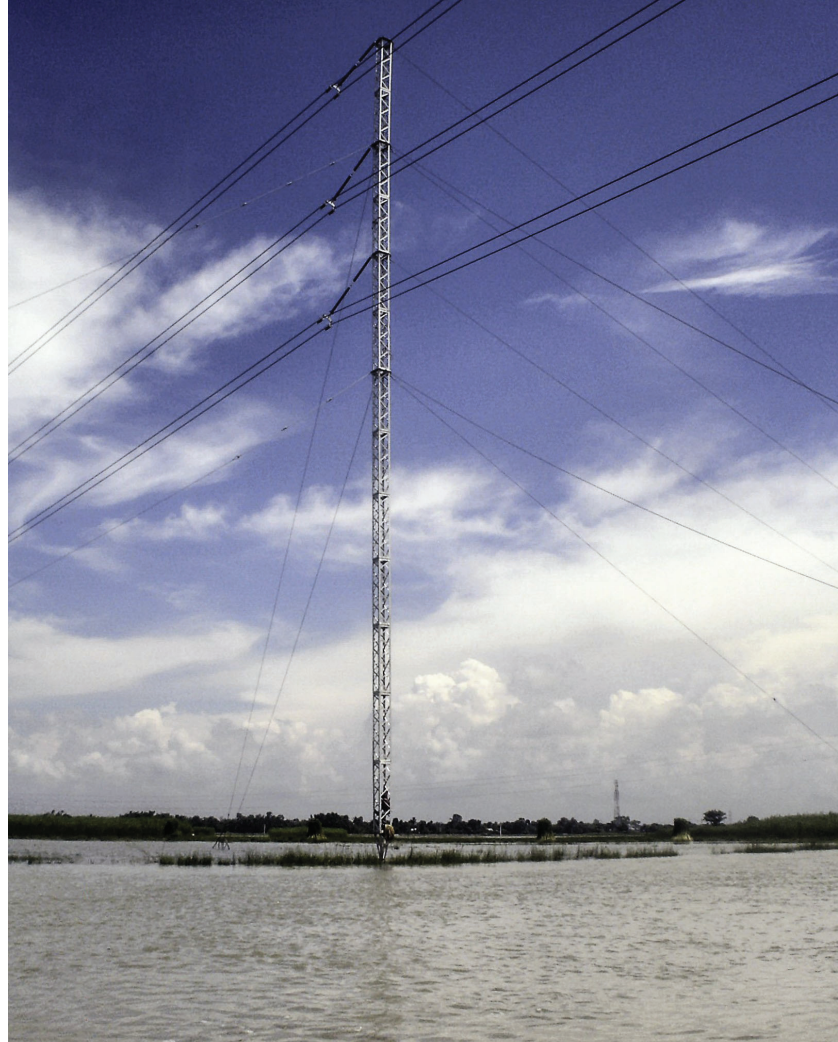
Figure 1. ERS Structure after flooding of the Patna River

As feared, the river did overflow its banks. The resulting flooding of the foundations and submersion of the anchors took place without incident. See Figure 1. After the flooding subsided, inspection showed the foundations remained in place and the anchors remained intact. See Figure 4.

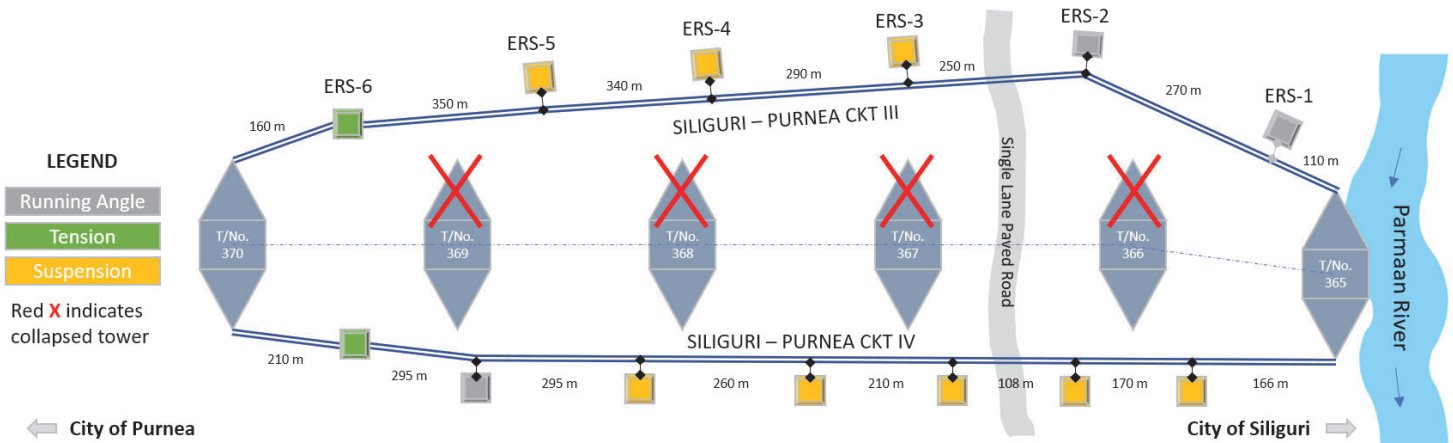
Powerlinks’ engineers determined 13 of Lindsey’s Series-600L ERS structures were needed to bypass the collapsed towers. See Figure 2.

Figure 2. ERS Restoration Scenario for 400kV Siliguri-Purnea Circuits III & IV Transmission Line

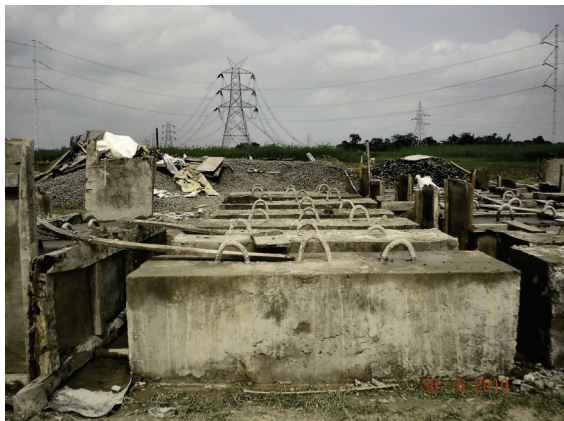
Complicating the restoration was the proximity of the Parman River. Due to the storm, flooding of the river was anticipated. This would result in erosion of the riverbank, and eventual submersion of one or more ERS tower's foundations. To secure the structures, Powerlinks' crews used a combination of concrete block (See Figure 3) and Manta-Ray anchors to support and reinforce each other.

Figure 3. Concrete block anchors after fabrication on-site

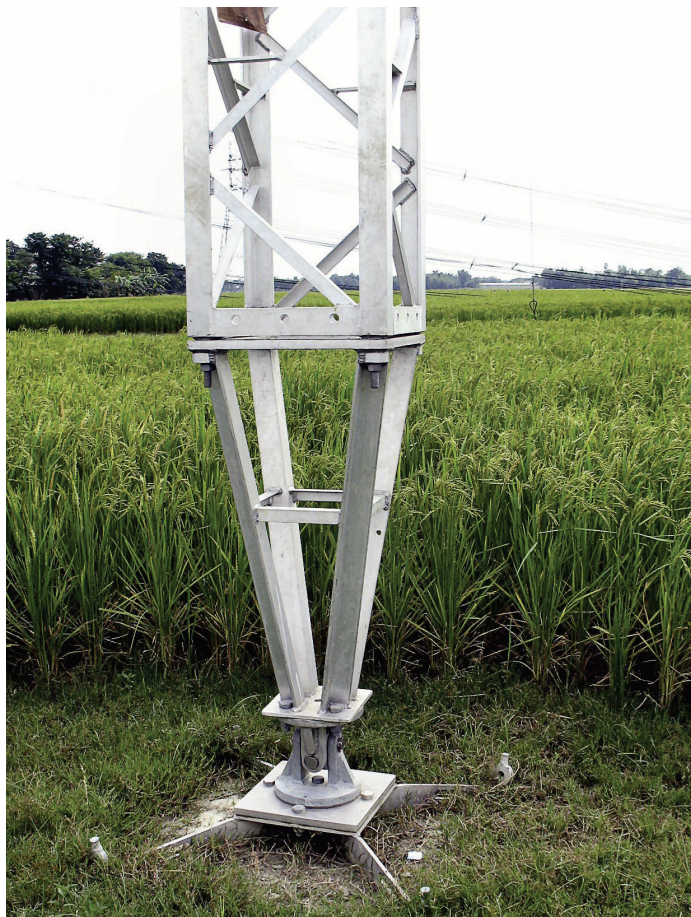
Figure 4. After flood waters receded, examination of the ERS foundations showed them intact.

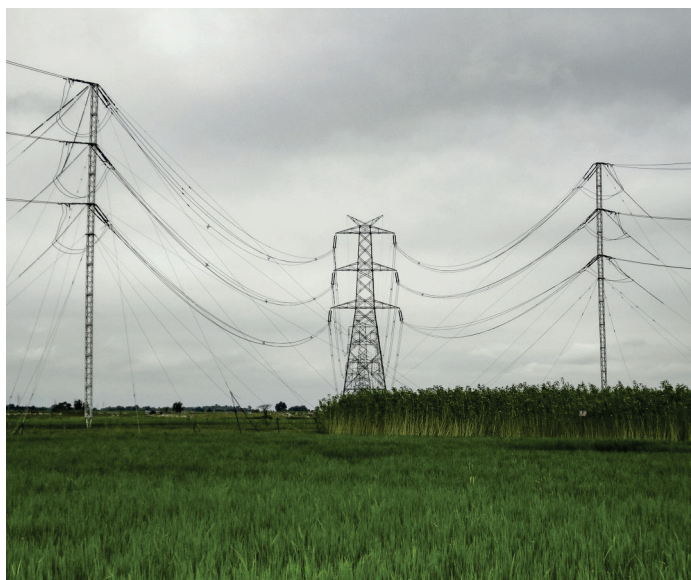
Figure 5 shows the restoration looking towards the Purnea end of the line. The complete restoration effort took a total of 4 days to complete. The ERS towers stayed in service for approximately 3 months.

Figure 5. Two tension ERS structures pick up the two 400kV circuits from Tower 370 (looking west toward Purnea)
