# Transmission Emergency Restoration Systems For Public Power

Dr. Keith E. Lindsey\*

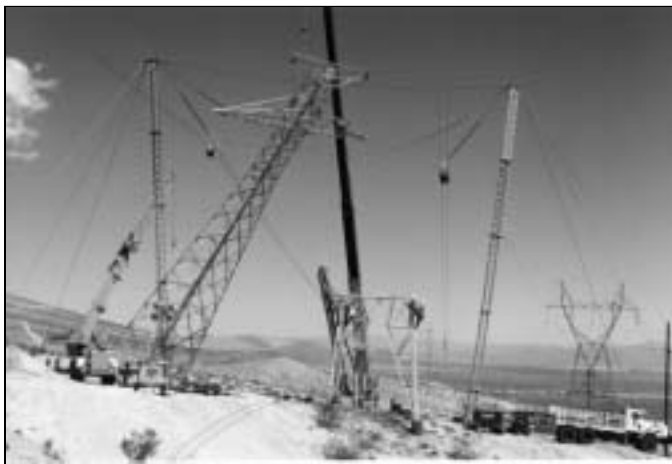
Figure 1  
Permanent restoration of a self-supporting DC Intertie tower. The de-energized conductors are supported in the IEEE Standard 1070 ERS, the Owens line is shown at the right.

The permanent restoration of the DC Intertie was contingent on delivery of self-supporting tower steel, and the availability of DC Intertie. During the week of March 27, the northern crew transported the tower steel to the site and assembled the tower for erection, completing the restoration (see Figure 1).

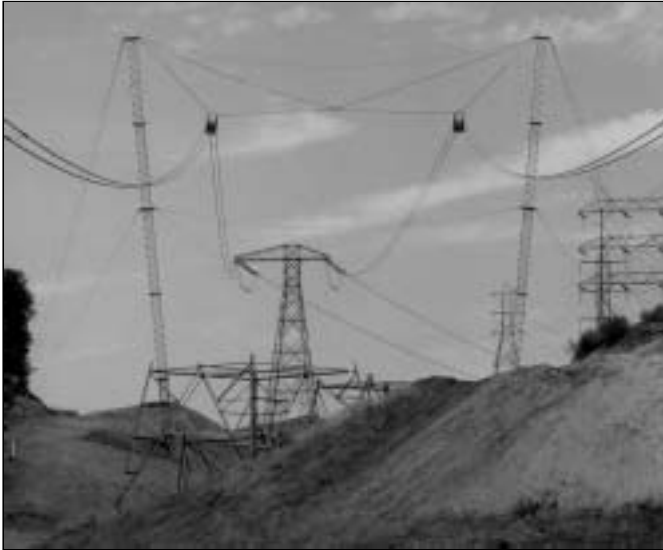
Figure 2  
An ERS Chainette type structure is used to support the 500kV DC Intertie. Note the residential area to the left of the damaged tower and the steep down guy angle of the ERS.

LADWP crews immediately responded. They grounded and snubbed the conductor to prevent further damage, and a roadway under the line was barricaded for public safety. As a similar self-supporting tower was not available, LADWP crews installed a temporary IEEE Standard 1070 ERS structure. Due to the close proximity of residential houses, a steep down guy angle was required (Figure 2),. This was quickly analyzed using the emergency restoration structure structural analysis computer programs.

Crews work around the clock using night lights. Conductor hardware and insulators were replaced on the adjacent tension tower and new conductor was spliced in and sagged. Spacers were installed and the line energized within 36 hours after the start of the outage.

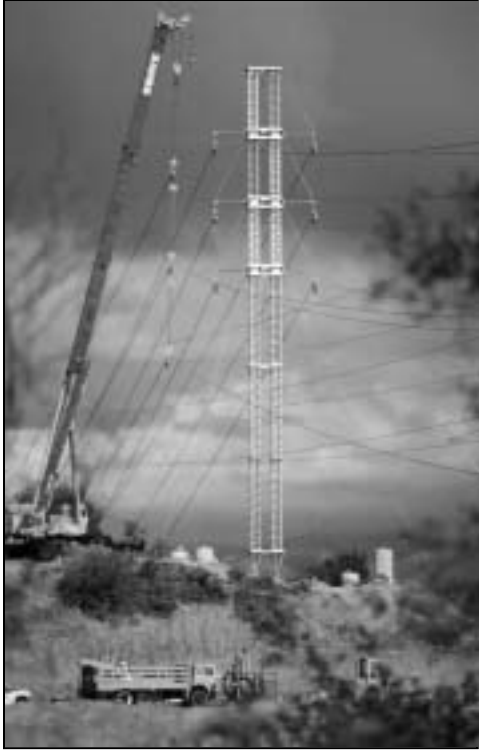
**Figure 3**  
One 230kV circuit at the left is supported by the crane; two other circuits are supported by an IEEE Standard 1070 ERS. This double circuit 230kV ERS structure was designed for a narrow right-of-way.

In order to support the load that was being brought back on line, two more circuits of this critical 230kV line needed to be restored. In order to accomplish this a special double circuit narrow right-of-way ERS structure made from the same IEEE Standard 1070 components was erected next to the energized circuit in the crane (see Figure 3). By the morning of January 19, all three circuits were energized.

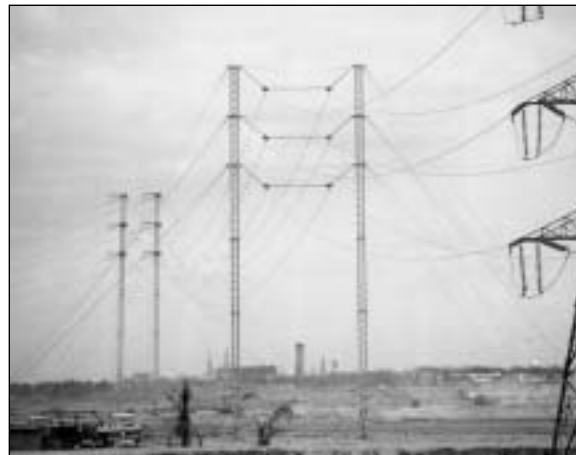
The double circuit ERS suspension tower above and the two ERS tension towers were used to replace tower T26A on the Mexico-Hermosa line

In order to stabilize the system and prevent low voltage problems in the city of Manila, NPC purchased an ERS in order to restore four of the five circuits in the lahar affected area. Figure 5 shows a double circuit herringbone emergency restoration structure used for an in-line restoration of the double circuit 230 kV

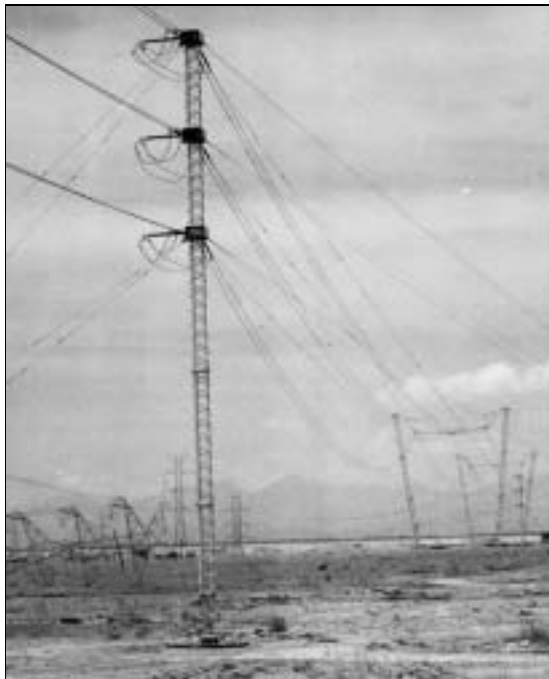
The two ERS tension tower and two ERS chainette tower at the left, were used to bypass one circuit of the San Jose-Hermosa line. Tower T69 can be seen to the left. Another ERS bypass was eventually used to remove the energized circuit still attached to tower T69.

Mexico-Hermosa line. Figure 6 shows a by-pass restoration using two tangent chainette and two dead-end structures to restore one circuit of the San Jose-Hermosa 230kV

transmission line. Installation of the ERS required adding wood cross arms beneath the ERS foundation in order to increase the bearing area of the foundation in the soft lahar. Swamp type screw anchors were installed to guy the ERS structure. The foundations were tied to these anchors using steel guy wire, to prevent them from moving during additional new lahar flows.

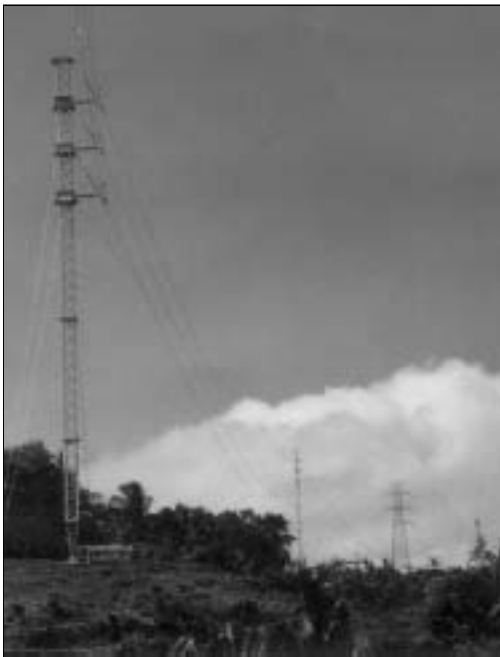
Figure 7  
The photograph at the left shows the first circuit to be repaired. The conductor is transferred from Tower No.23 to one ERS while the ERS in the foreground bypasses Tower No. 24, destroyed by a mud slide.

In October of 1996, heavy rains caused a massive mud slide that completely destroyed a full tension tower No. 24 and damaged a cross arm on suspension tower No. 23 on the Abaga-Tagoloan double circuit 138kV transmission line in Mindanao, Philippines.

It was decided to restore both circuits with four horizontal-vee ERS structures. Due to the remote location, all ERS material had to be hand carried the last 2km to the site of the land slide. The four horizontal-vee ERS structures were built in five days using an aluminum gin pole and a small portable capstan hoist. The foundation of the ERS was placed on the sloping and unstable soil of the mud slide. It took an additional two days to transfer the conductor. Figure 7 shows one of the circuits transferred and the ERS for the second circuit under construction. Both circuits were re-energized in seven days.

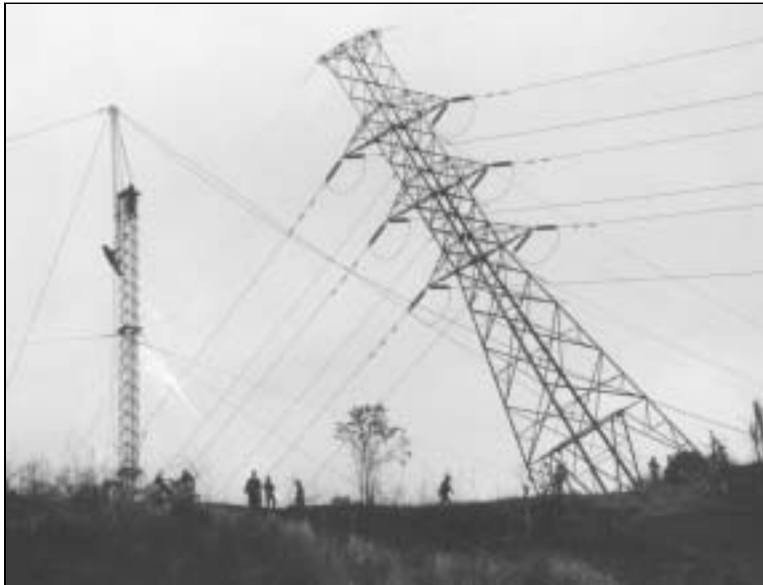
Figure 8  
Vandals cut the legs of tension tower No. 44. This tower is located on the top of a narrow ridge. In order to keep the line energized, the conductor from one circuit was transferred to the ERS horizontal-vee structures while the other circuit was energized.

voltage at the load center. To complicate matters, the tower was located on the top of a narrow ridge, and the only access to the site was by helicopter. See Figure 8.

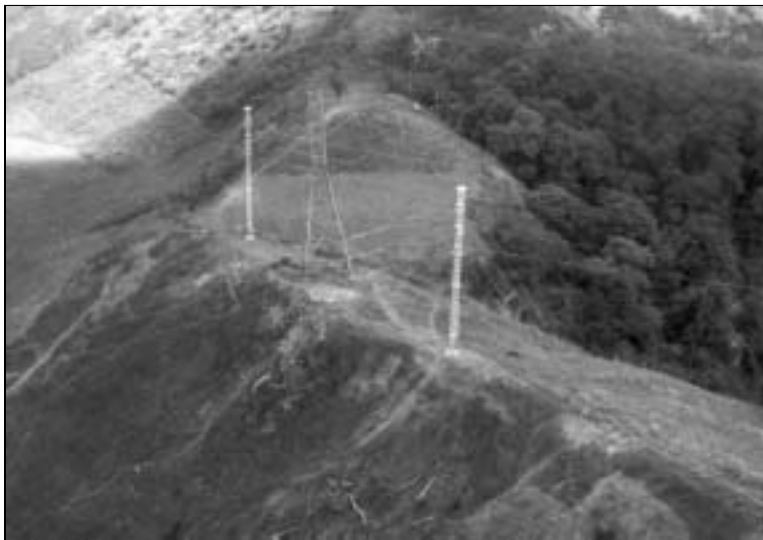
Figure 9  
The photograph to the left shows the placement of the two ERS horizontal-vee structures directly on top of the ridge. Note that the dead-end insulators and hardware are in the span and to the left of the ERS in the foreground.

Two ERS horizontal vee temporary towers were used to bypass both circuits around the damaged tower. With these in place, the damaged tower could be replaced, as the foundation was not damaged. Access to this site was difficult. All line crews and equipment had to be flown in by helicopter. It took one day and 18 trips (of 20km each) to get all personnel and equipment to the site. Helicopters were required to fly in supplies everyday and the line crew camped at the site. Approximately 25 linemen were involved. A gin pole and small portable capstan hoist were used to construct each ERS horizontal vee tower. The horizontal vee towers were offset longitudinally from the damaged tower approximately 2 to 4m on either side. Since the site was on top of a ridge, the back and side guys on the ERS horizontal-vees were two to three times longer than normal, as can be seen in Figure 9.
