# PLANNING AND TRAINING REDUCE RESTORATION TIME FOR DAMAGED TRANSMISSION LINES IN INDIA

L. N. Agrawal  
Power Grid Corporation of India Ltd.  
India

Paul. E. Erickson, P.E.  
Lindsey Manufacturing Company  
United States

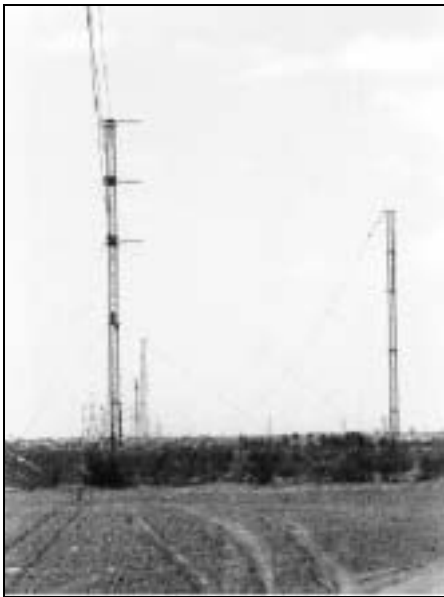
Figure 6

Temporary 220kV ERS tower used to restore the Panandru-Anjar line after the Gujarat cyclone.

This natural disaster could not have been predicted. Because of the high winds and severe flooding, several major transmission lines of Gujarat State Electricity Board were destroyed. Because of the much-needed requirement of power in the cyclone affected area, POWERGRID undertook the challenge of rapidly restoring several of the vital transmission lines. As an example, three towers were destroyed on the double circuit 220kV transmission lines from Panandru thermal power station to Anjar. These lines were rapidly restored using cranes and other heavy equipment along with POWERGRID's ERS. Power was restored on the first circuit on the 18<sup>th</sup> of June using four ERS towers while the second circuit was restored on the 23<sup>rd</sup> of June using another four ERS towers. These transmission circuits shown in figure 6, were restored in 5 to 6 days time under very adverse post cyclone conditions as opposed to restoration time

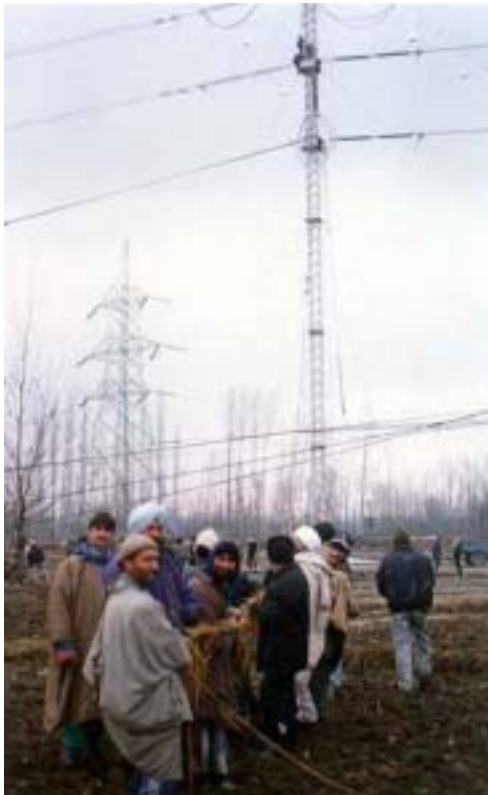
Figure 8  
Erection of the 400kV single circuit 15-degree tension ERS tower using manpower to pull the two conductors of the bottom phase.

After transporting the ERS to location no. 268 of the 400kV Uri-Wagoora line, the actual work started on the 19<sup>th</sup> January under very adverse and cold and snow climate (see figure 8). One 15-degree in-line dead end structure (101 ft. high) supported by 18 guy anchors was used to bypass the damaged tower at location no. 268 (see figure 9). The two conductor bundle spans were 416m on one side and 300m on other side.

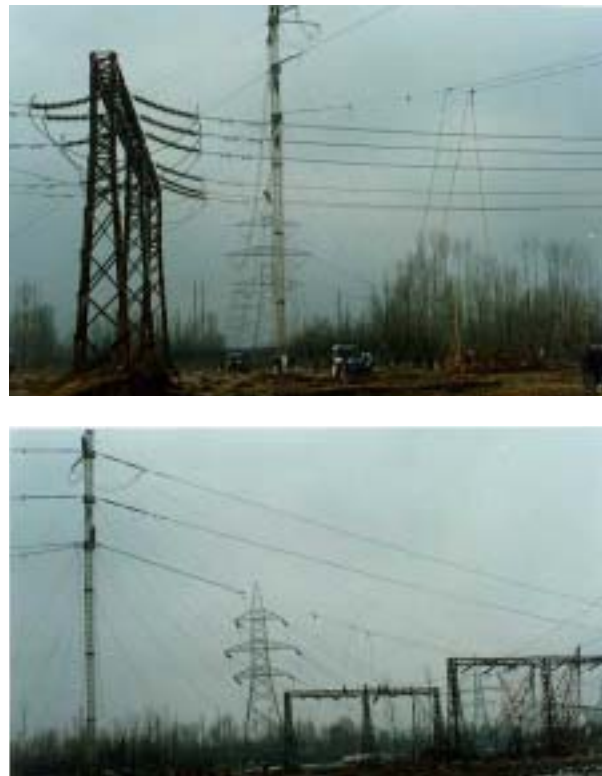
Figure 9  
Two views of the almost completed 400kV ERS tension tower showing the span over the double circuit 220kV line.
