# PLANNING AND TRAINING REDUCE RESTORATION TIME FOR DAMAGED TRANSMISSION LINES IN INDIA

L. N. Agrawal  
Power Grid Corporation of India Ltd.  
India

Paul. E. Erickson, P.E.  
Lindsey Manufacturing Company  
United States

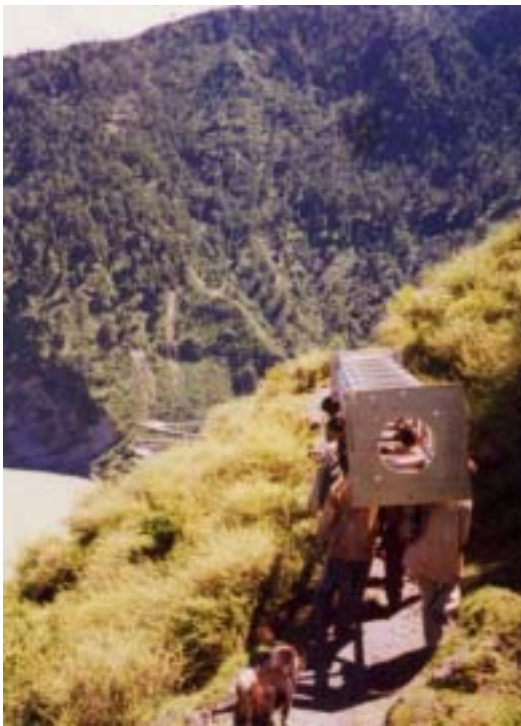
Figure 2

Fourteen-foot ERS column section being hand carried to the construction site, along a typical trail.

Prior to the restoration in September 1996, POWERGRID Engineers developed bills of material for the proposed bypass towers and began to move the equipment from storage areas to the tower site. The closest road and staging area was approximately 2.5 km from the tower site. All of the equipment had to be hand carried from the staging area (see Figure 2). The site conditions were very difficult. The original tower was constructed on steep sloped terrain. The average slope of the terrain towards the river was 40 degrees.

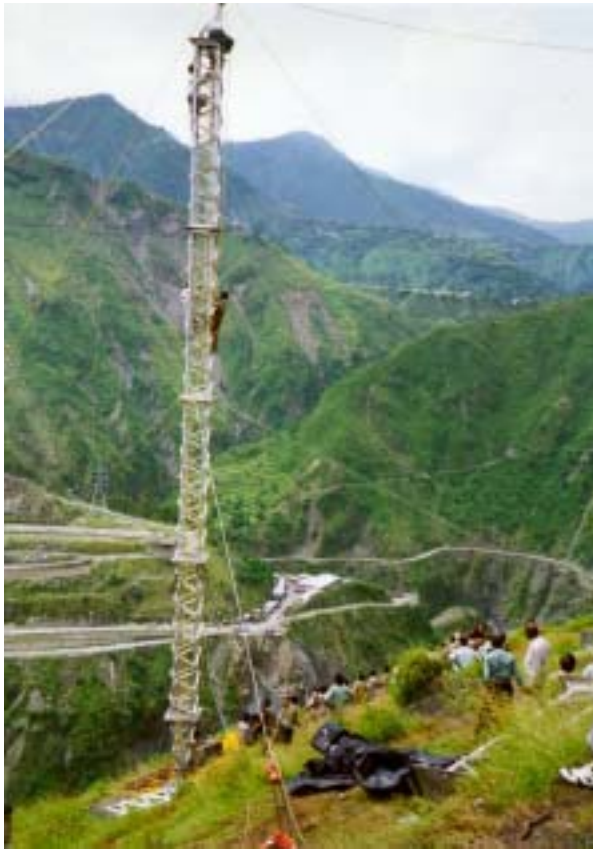
Figure 3  
Erecting the bypass for Tower 59 using a Gin Pole and manpower to lift the ERS components.

POWERGRID Engineers determined that two, three phase tension structures would work best for the given site condition. The Engineers located the two foundation sites and the related anchor positions. Once the anchor plates were buried the actual construction of the towers began. ERS foundations were located and staked down, the ERS gimbal was bolted to the foundations and an aluminum gin pole or derrick, supplied with the ERS, was moved into place and each ERS tower erected (see Figure 3). Each tower was completed in approximately one day. Once both towers were completed, new conductors were strung between the ERS towers. An eight (8) hour outage was then taken to transfer the conductor from tower 59 to the ERS 12 degree strain tower. This was accomplished by using a block and tackle to lower the conductors from tower 59 to the ground and then pulling the conductors into position on the ERS towers. On September 20 the bypass transmission line was energized (see Figure 4).

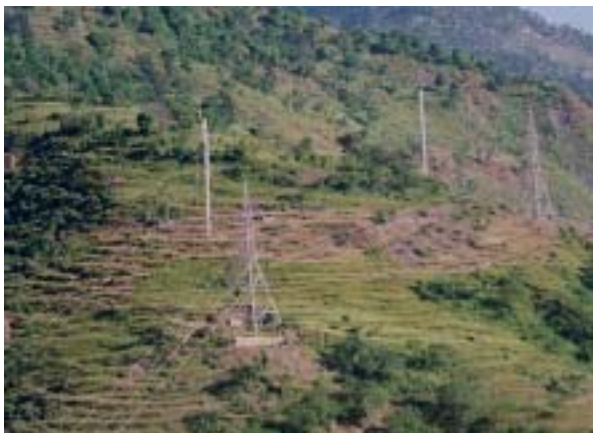
Figure 4  
Completed ERS bypass of towers 58 and 59.

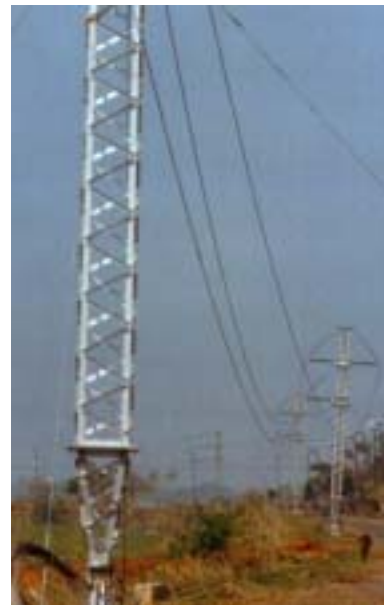
Figure 7

One of several ERS towers used to restore power after the Orissa cyclone.

anchoring of the towers. Even with this difficulty, POWERGRID crews restored all damaged transmission lines of 23kV and above (see Figure 7). Restoration of lesser lines was undertaken by Gridco, the major provider of electric power in the state of Orissa.

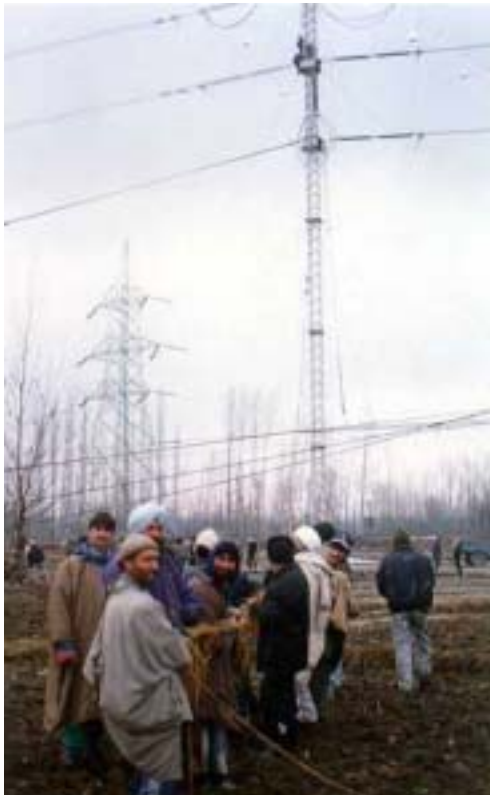
Figure 8  
Erection of the 400kV single circuit 15-degree tension ERS tower using manpower to pull the two conductors of the bottom phase.

After transporting the ERS to location no. 268 of the 400kV Uri-Wagoora line, the actual work started on the 19<sup>th</sup> January under very adverse and cold and snow climate (see figure 8). One 15-degree in-line dead end structure (101 ft. high) supported by 18 guy anchors was used to bypass the damaged tower at location no. 268 (see figure 9). The two conductor bundle spans were 416m on one side and 300m on other side.

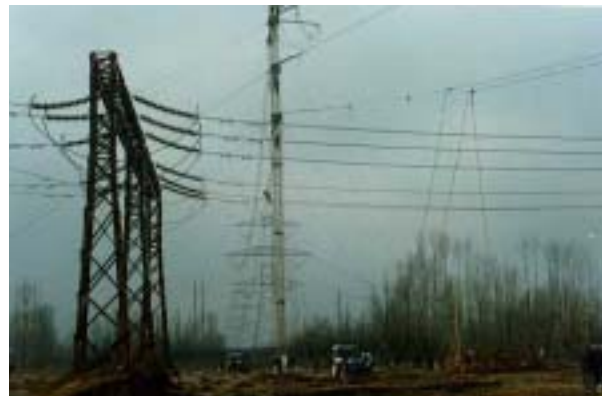
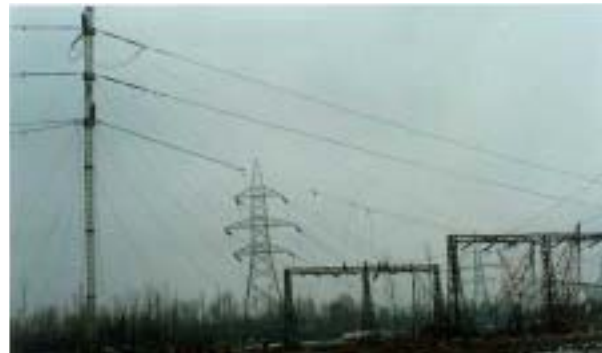
Figure 9  
Two views of the almost completed 400kV ERS tension tower showing the span over the double circuit 220kV line.
