PLANNING AHEAD PROVES INVALUABLE  
TO THE RAPID RESTORATION OF THE PACIFIC DC  
INTERTIE AND OWENS GORGE TRANSMISSION LINES

STEPHEN A. RUTTY   JOHN K. JACKSON   DAVID A. DELUCA  
LOS ANGELES DEPARTMENT OF WATER AND POWER

PRESENTED AT  
11th IEEE/PES TRANSMISSION AND DISTRIBUTION  
CONFERENCE AND EXPOSITION  
NEW ORLEANS, LOUISIANA  
APRIL 2-7, 1989

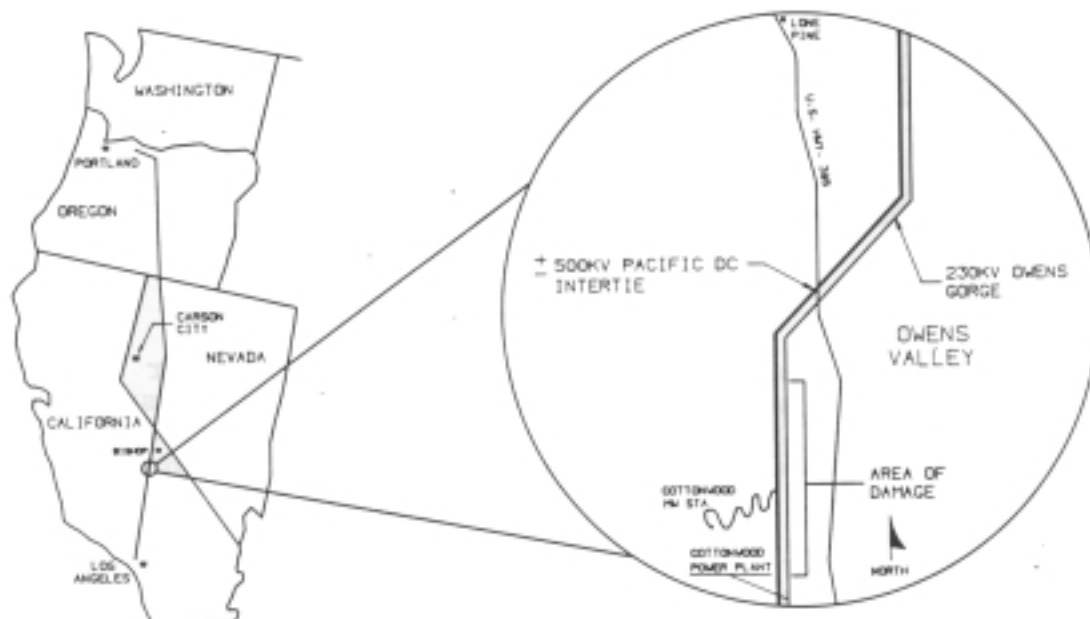
**Figure 3**

The 846 mile Pacific DC Intertie was originally built in 1968-69 from the Pacific Northwest to Southern California. North of the Nevada-Oregon border, the line is owned and maintained by the Bonneville Power Administration. South of the Nevada-Oregon border, the line is collectively owned by Southern California Edison, LADWP, and the cities of Burbank, Glendale and Pasadena. LADWP is responsible for maintaining the line south of the Nevada-Oregon Border. In the Owens Valley area, as shown in the inset, the Owens Gorge line runs parallel to the Pacific DC Intertie.

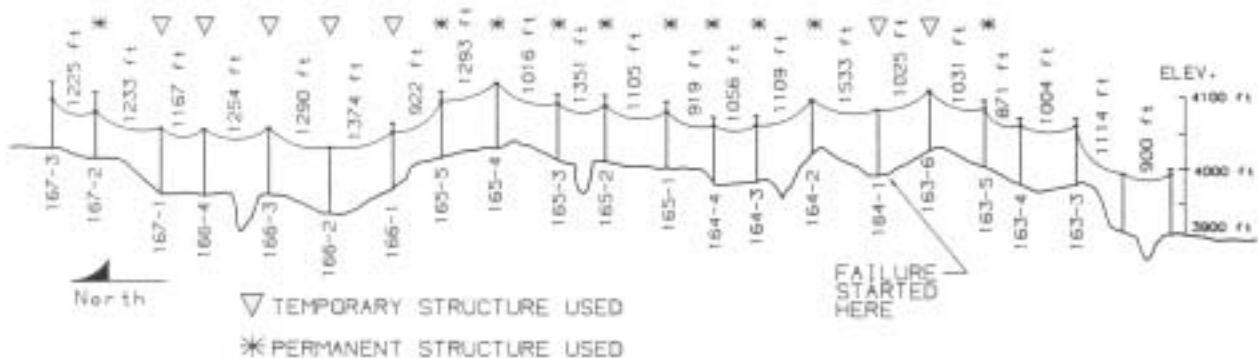
**Figure 4**

It is believed the incident began with the failure of Pacific DC Intertie Tower 164-1 (see Figure 4). This tower moved 100 feet across the right-of-way, into the adjacent Owens Gorge line and destroyed one Owens Gorge tower. The Pacific DC Intertie failure cascaded north, taking out 13 guyed structures and one self-supporting structure. To the south, two guyed towers were lost. Additional towers to the north and south sustained damaged ground wire peaks. Six Gorge towers, in addition to the one destroyed Owens Gorge tower, sustained damage ranging from bent tower members to collapsed ground wire peaks.

The terrain profile above shows the damaged section of the Pacific DC Intertie.

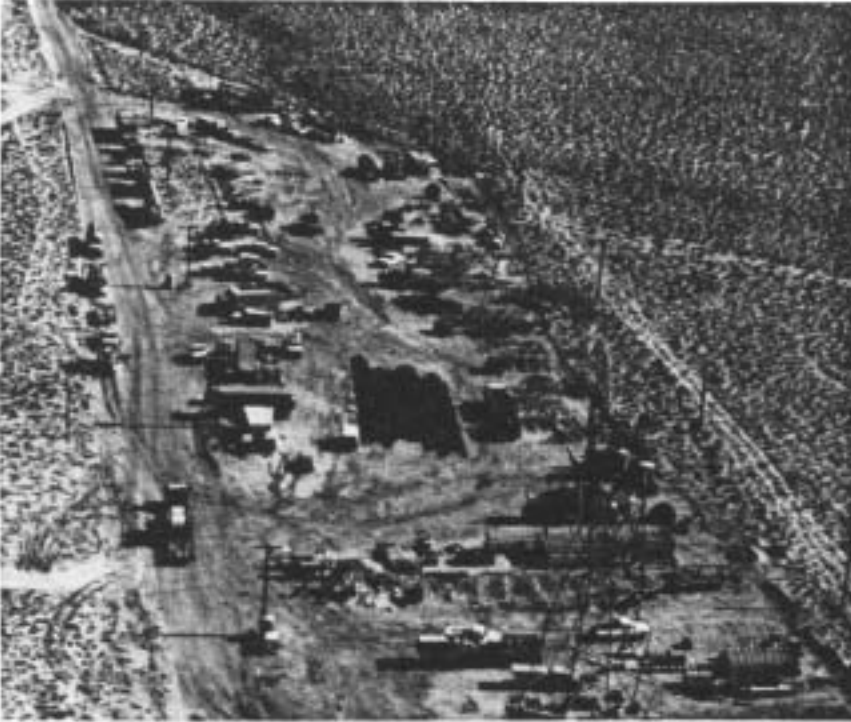
**Figure 7**

The marshaling yard was set up about midway along the damaged area. As materials and equipment began to arrive it was sorted, inventoried and stored in the marshaling yard until required. Power and telephone service was provided to the yard by local residents.

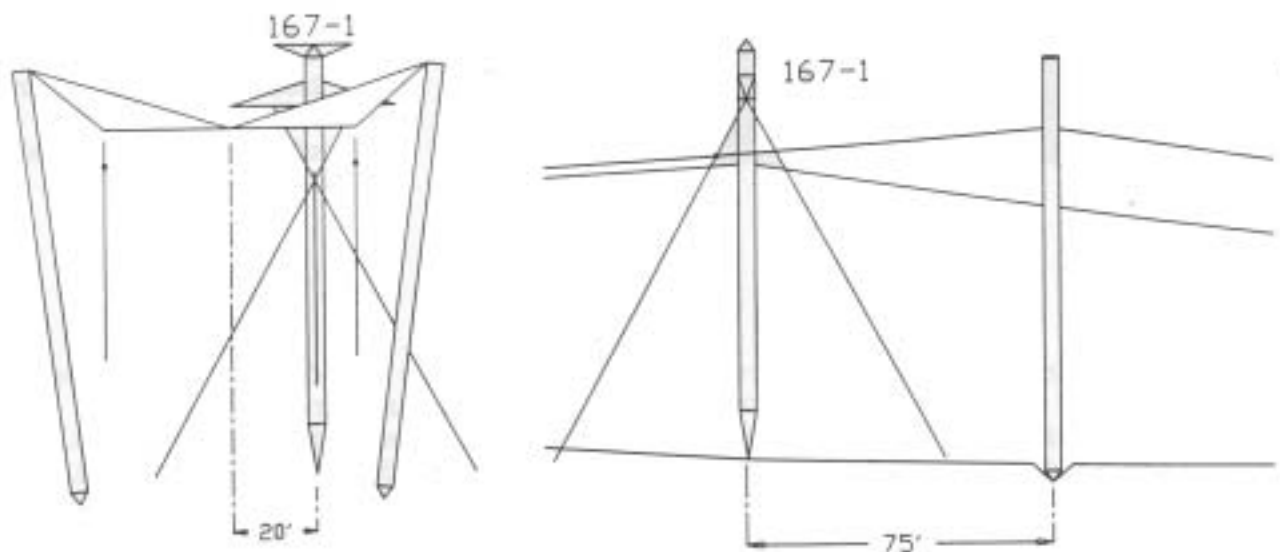
Figure 12

Both a two dimensional (shown above) and a three dimensional computer model of the temporary and permanent structures verified that the planned restoration work method was feasible. These models also aided in determining the proper placement of the required equipment.

On the Pacific DC Intertie, it was necessary to develop a method of erecting the permanent towers while minimizing the required outage time. The proposed method involved assembling and erecting the permanent towers, transferring the conductors from the temporary structures, and dismantling and removing the temporary structures. A computer model of the temporary and permanent structures, including guy wires and conductors, was developed by Transmission Engineering in order to determine the feasibility of this method (see Figure 12). The model verified that the offset placement of the temporary structures during the emergency restoration was sufficient to allow for the proposed permanent restoration procedure.

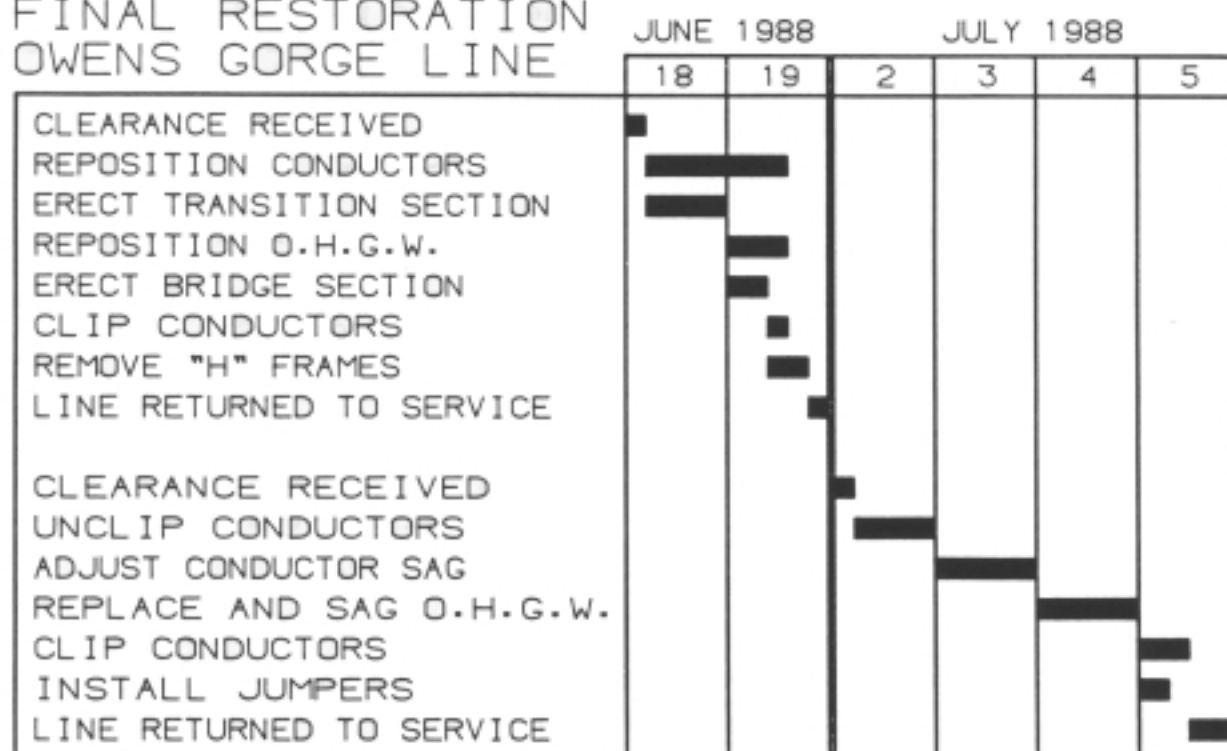
FIGURE 16

During this outage, two splice plates necessary to hold the tower body together did not fit properly. Fortunately, LADWP had spare plates, and the erection proceeded with only a half day delay.

The final restoration of the Owens Gorge line involved activities to install one new tower, remove two temporary wood pole structures, adjust conductor in the middle and western phases, and string overhead ground wire (see Figure 16). Three separate outages were scheduled to complete this work, with final restoration accomplished by July 5, 1988. More time was required to complete the Owens Gorge line restoration than the Pacific DC Intertie because of material supply problems.
